OPERATING EXPERIENCE WEEKLY SUMMARY

Office of Nuclear and Facility Safety

February 26 - March 4, 1999

Summary 99-09

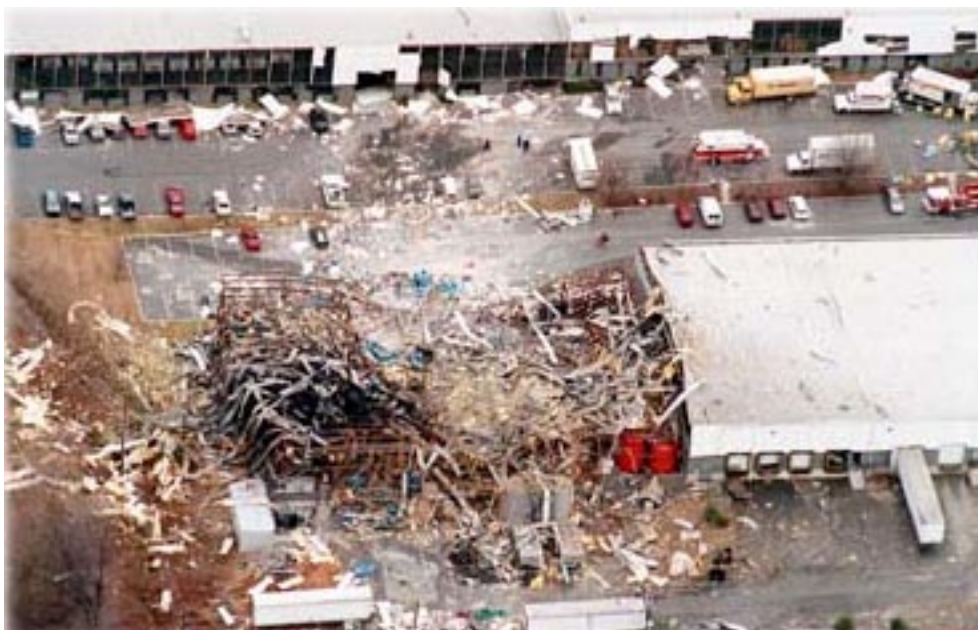
On February 19, 1999, an explosion at a Concept Sciences, Inc., chemical plant near Allentown, Pennsylvania, took the lives of five workers and injured at least 13 persons, including five firefighters. The blast completely destroyed a 45,000-square-foot section of the plant, damaged nearby buildings, and rained debris over a wide area (Figures 1-1 and 1-2). The blast also formed a crater approximately 18 feet in diameter and 4 feet deep through the building's concrete floor. The shock wave from the blast was felt for up to 5 miles and the sound carried for more than 15 miles. Workers were handling a solution of hydroxylamine and potassium salts when the accident occurred. DOE uses process quantities of hydroxylamine nitrate at the Savannah River F-Canyon, and other sites may store legacy hydroxylamine compounds or may use them in laboratory quantities. (Photos and description of event courtesy *The Morning Call* newspaper, Allentown, Pennsylvania)

Figure 1-1. Destruction at Concept Sciences, Inc., Facility

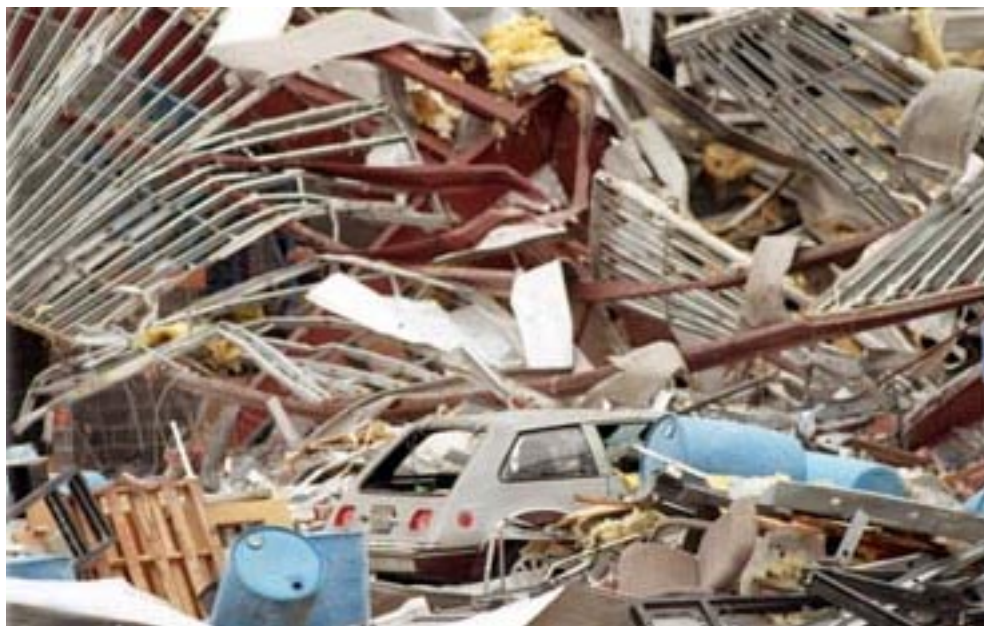
Figure 1-2. Destruction at Concept Sciences, Inc., Facility
